Stream Channel Stability  
Investigations of Vegetation for Stabilizing Eroding  
Streambanks

INVESTIGATIONS OF VEGETATION FOR STABILIZING ERODING STREAM BANKS

USDA Sedimentation Laboratory  
Oxford, Mississippi

Prepared for  
US Army Corps of Engineers, Vicksburg District  
Vicksburg, Mississippi

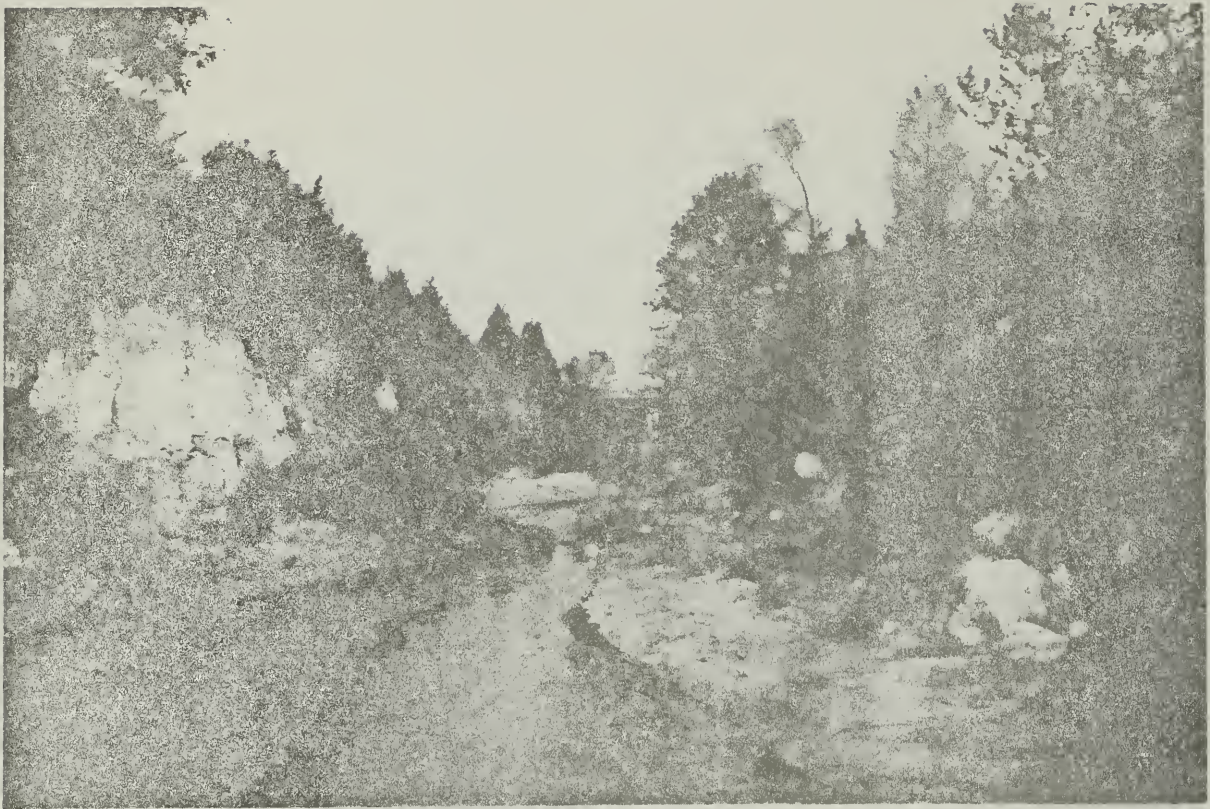
Figure 2 Typical Channel Cross Section of Johnson Creek.

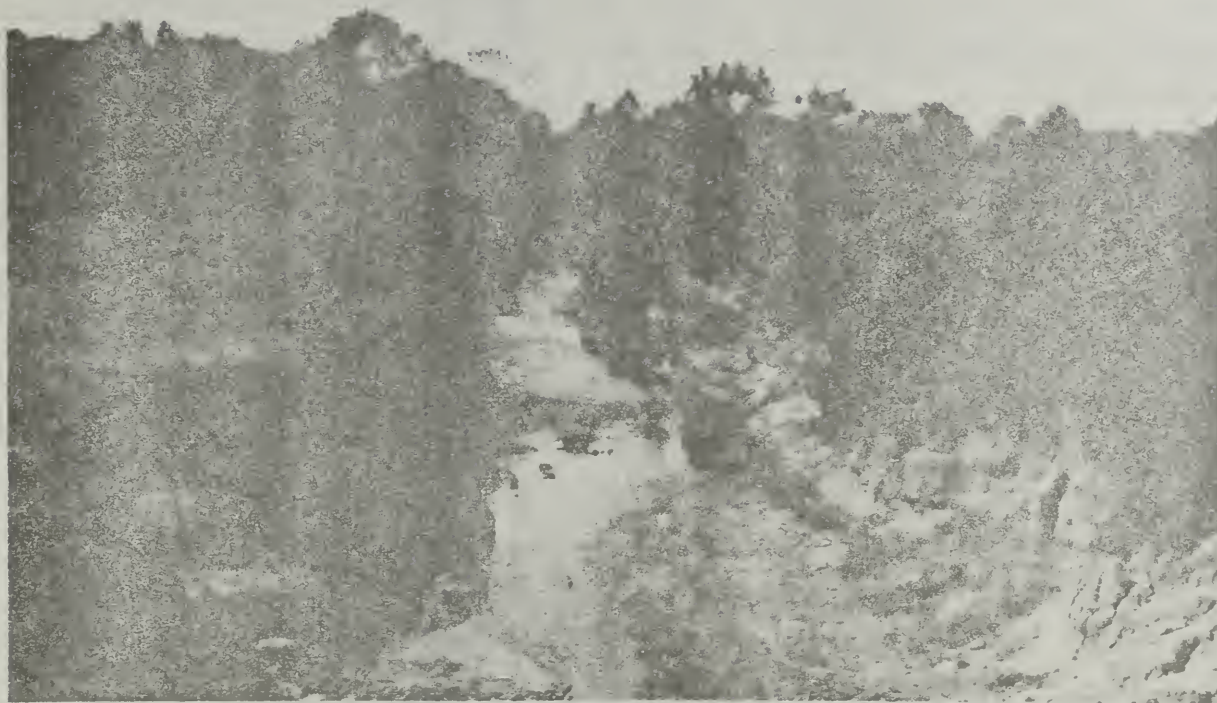
Figure 7 Downstream View of Johnson Creek Study Reach No. 3 Prior to Construction

A downstream view of the study reach just prior to construction is shown in Fig. 7. A view from the same location after completion of construction is shown in Fig. 8.

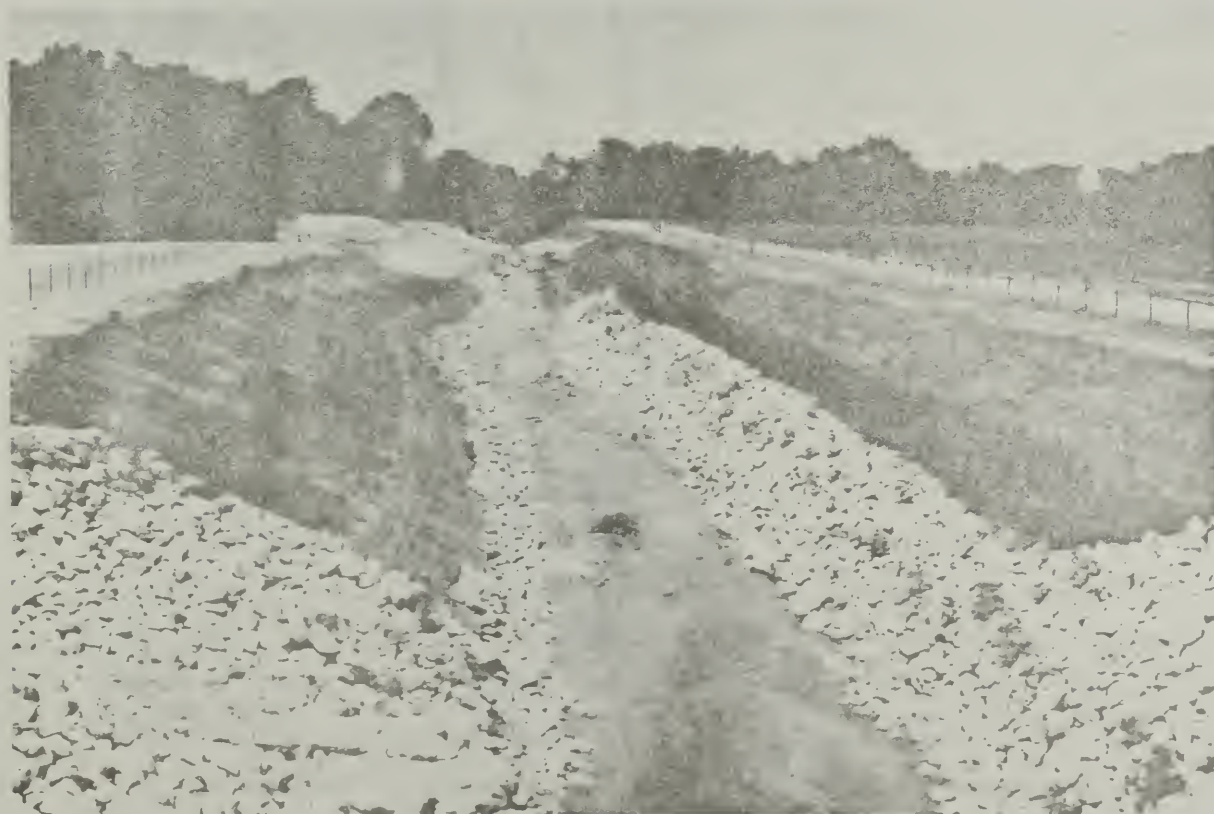
Figure 8 Downstream View of Johnson Creek Study Reach No. 3 After Construction Completed

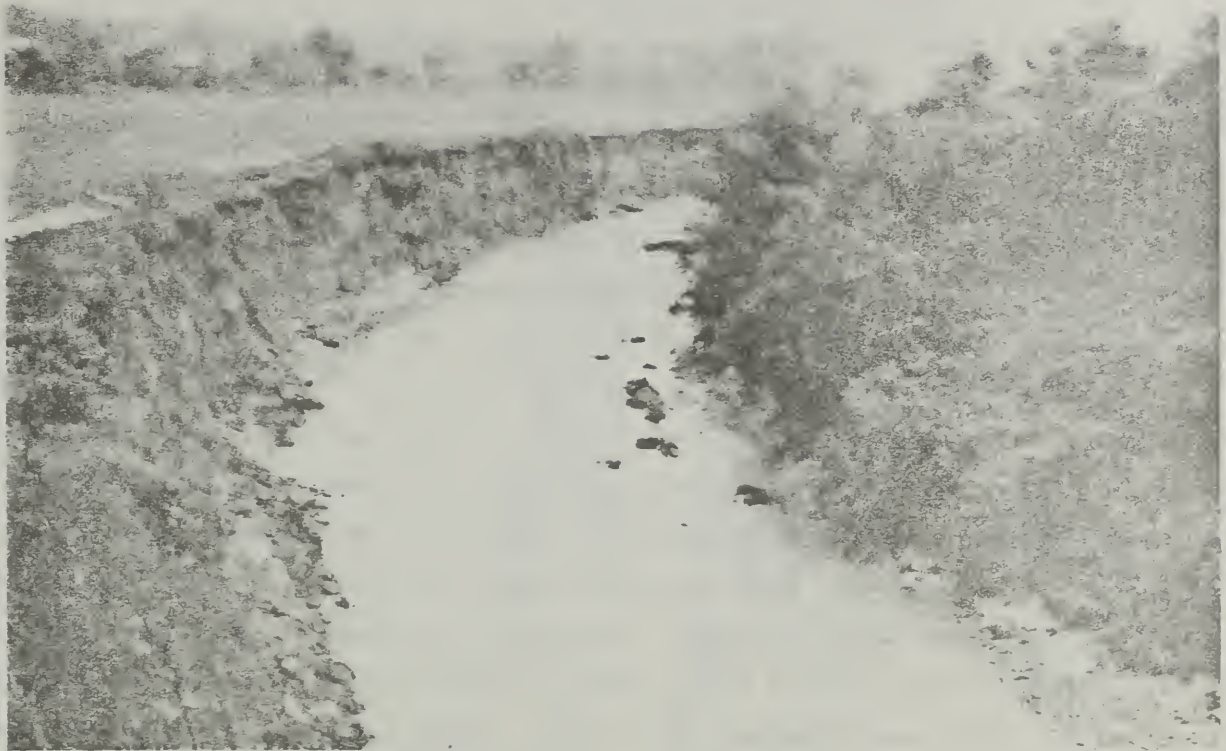
Figure 11 Upstream View of Johnson Creek Study Reach No. 4 Prior to Construction

An upstream view of the study reach prior to construction is shown in Fig. 11. A view from the same location after completion of construction is shown in Fig. 12.

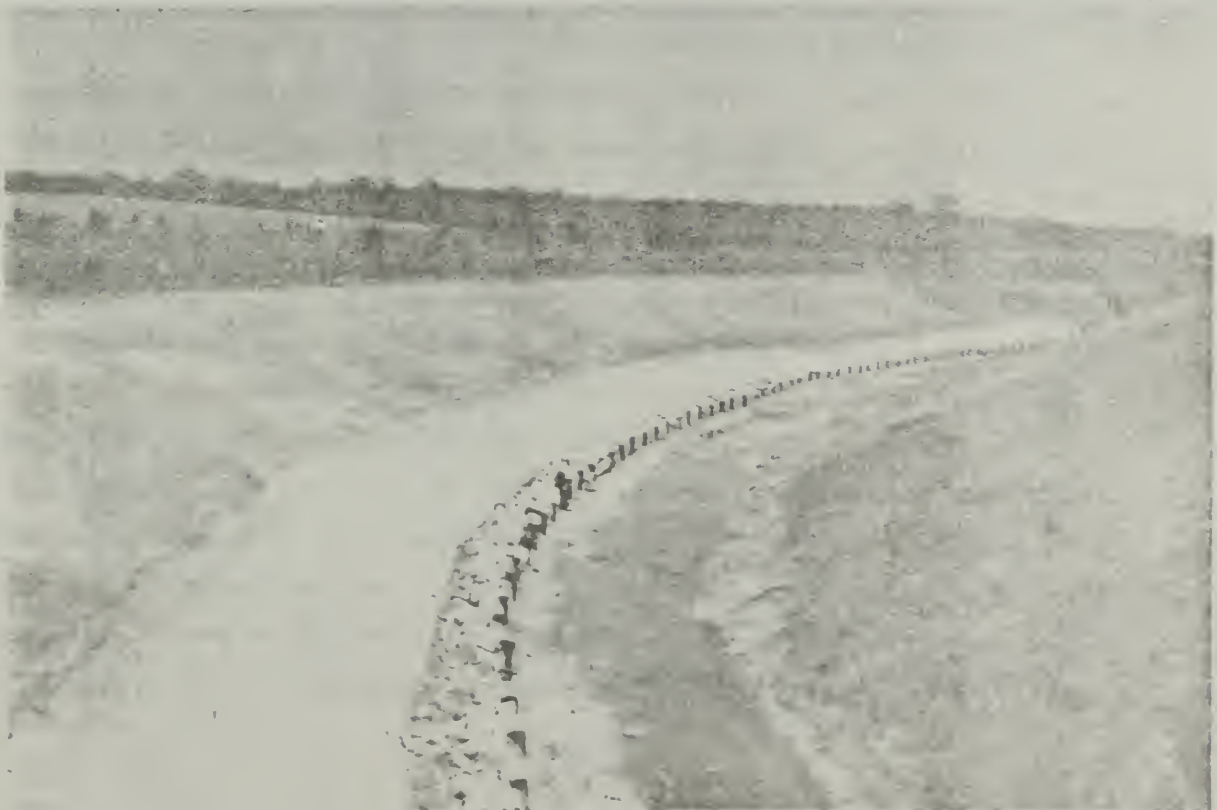
Figure 12 Upstream View of Johnson Creek Study Reach No. 4 After Construction

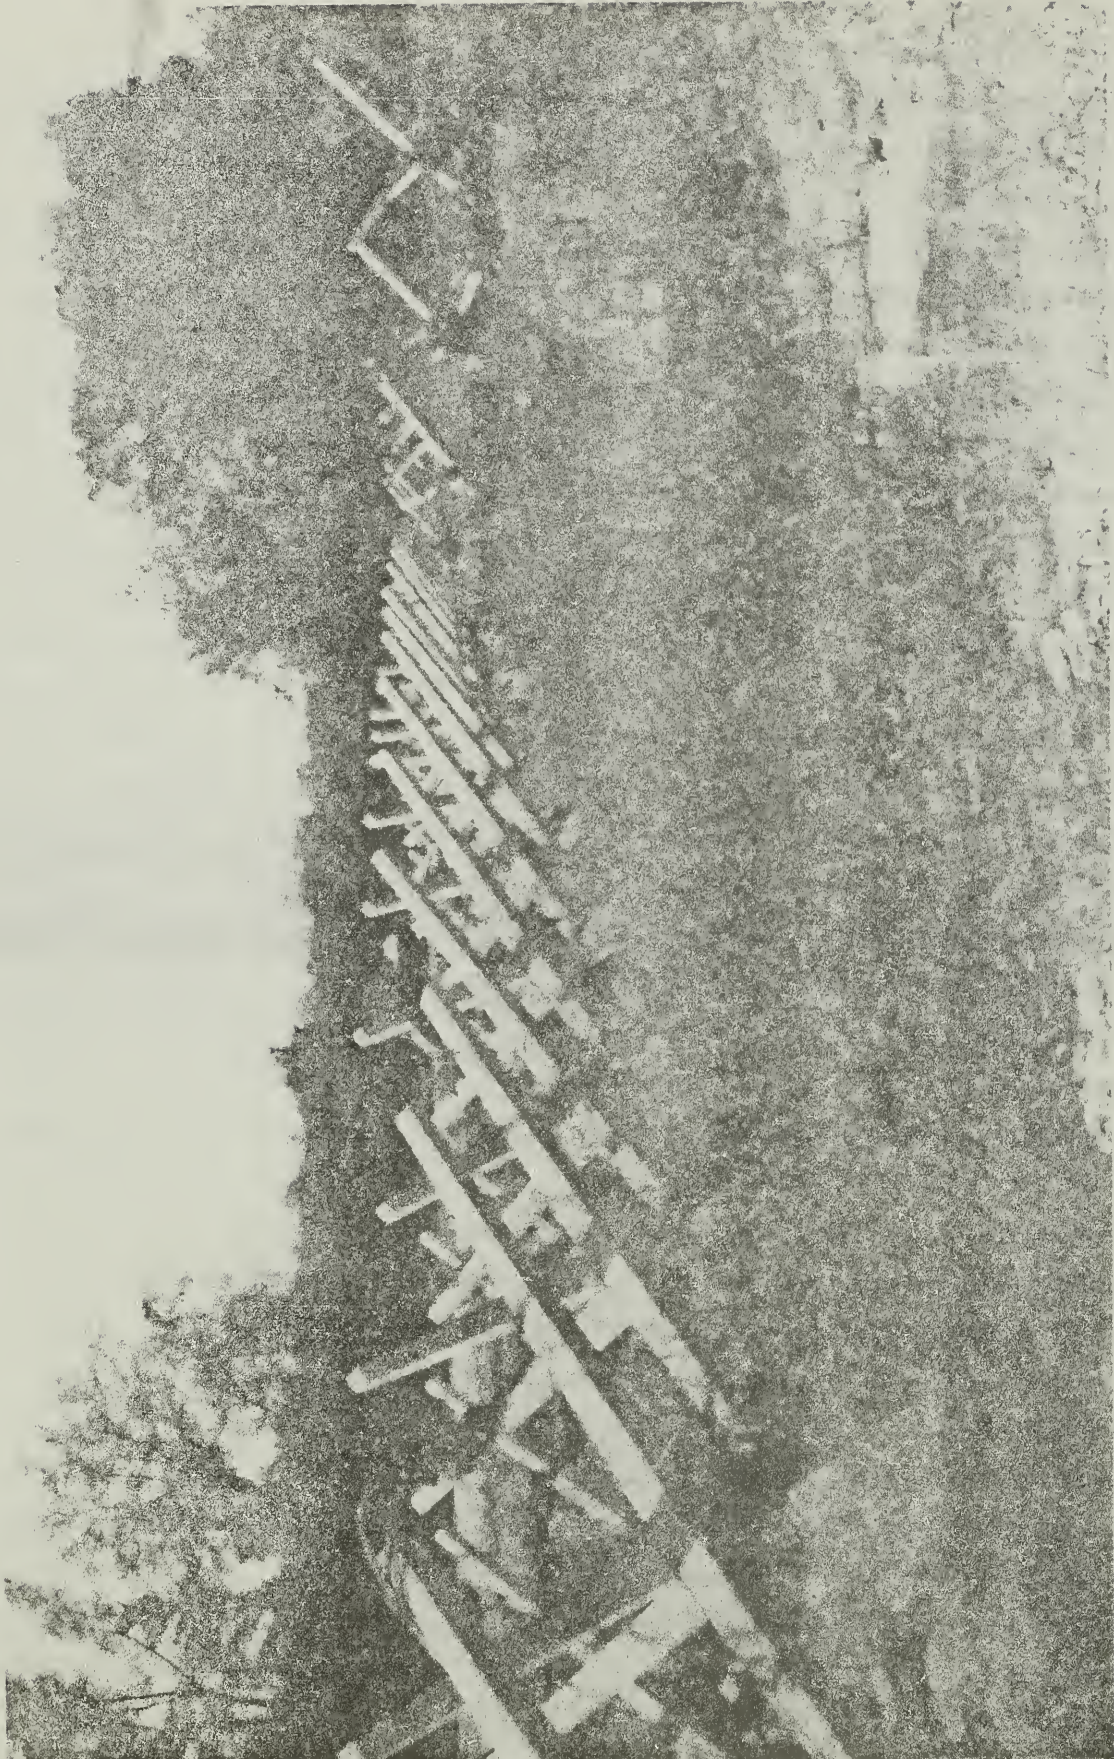
Figure 15 Peters Creek Study Reach No. 1 - One Year Growth of Native Black Willow Planted in a Kellner  
Jack Field

55 percent survival. The Peters Creek study reach no. 1 with native black willow planted between the channel bank and rows of concrete jacks is shown in Fig. 15.
